# REPORT OF APOLLO 204 REVIEW BOARD

**NATIONAL AERONAUTICS AND SPACE ADMINISTRATION**

Spacecraft 012 was undergoing a "Plugs Out Integrated Test" at the time of the accident on January 27, 1967. Operational Checkout Procedure, designated OCP FO-K-0021-1 applied to this test. Within this report this procedure is often referred to as OCP-0021.

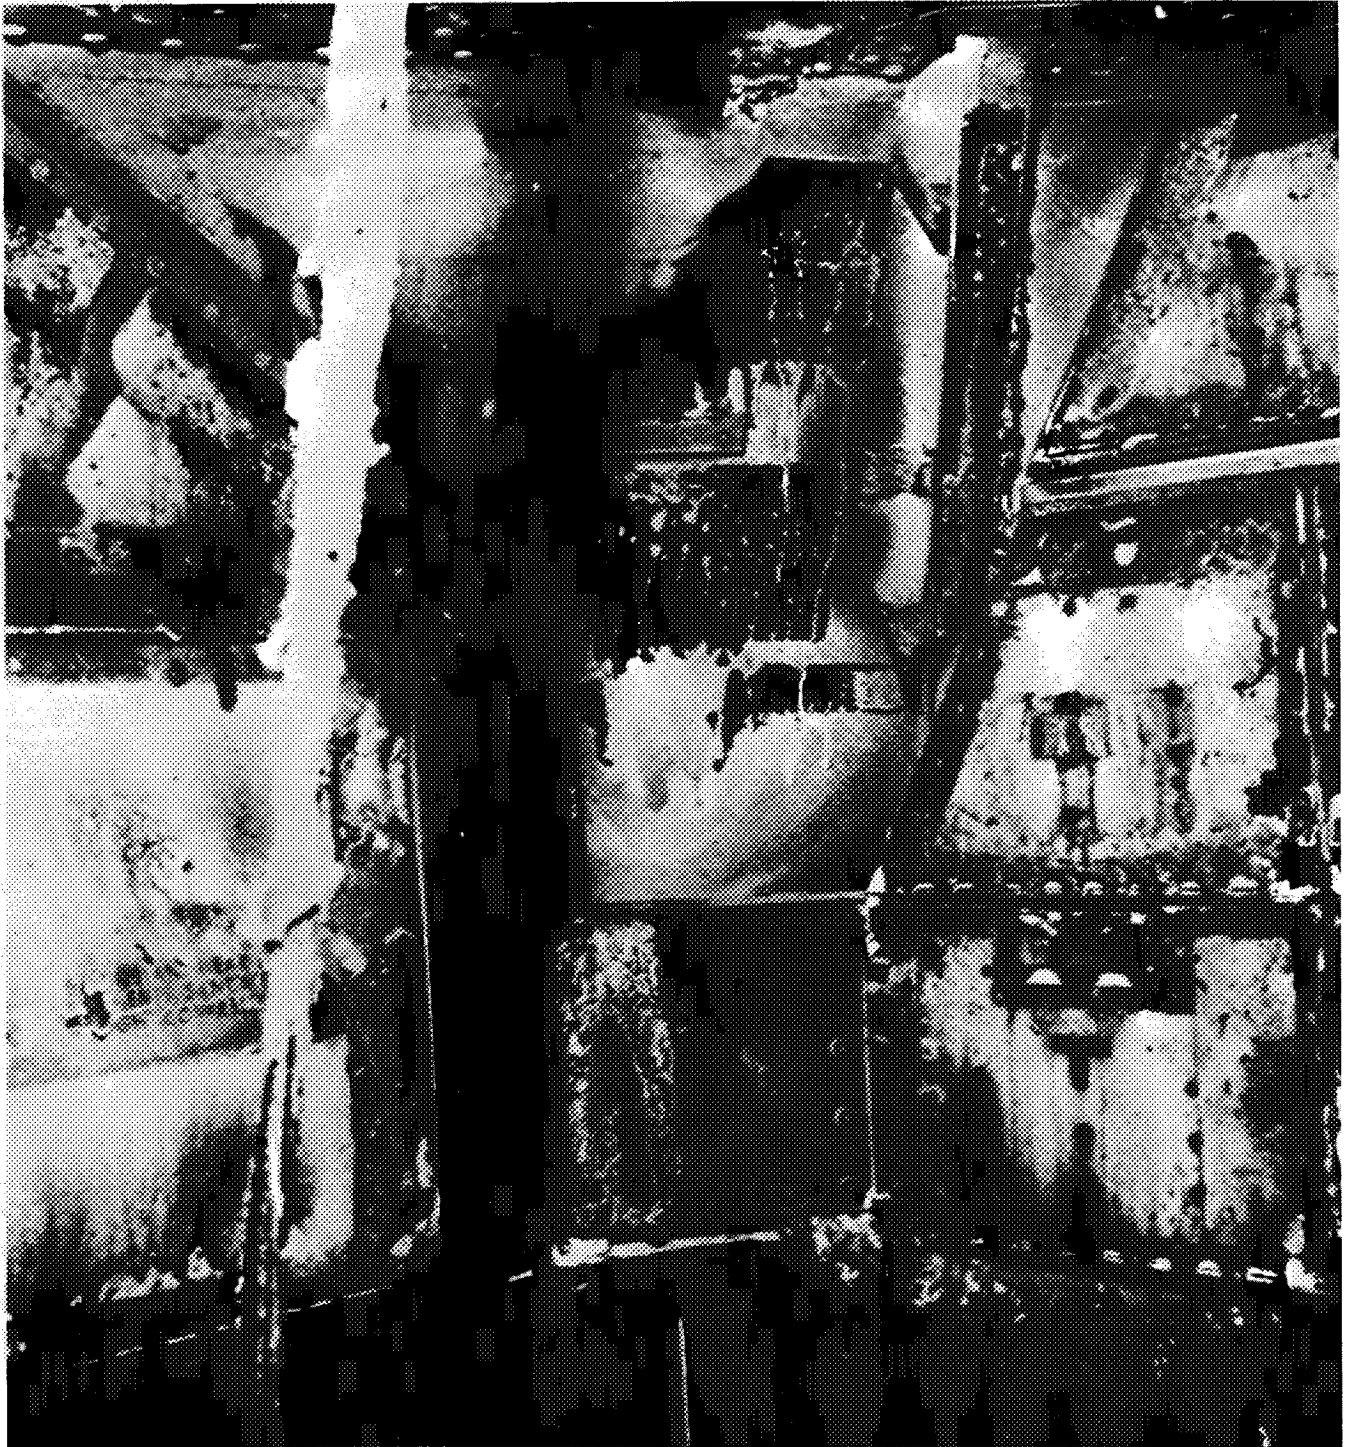
EXTREME UPPER LEFT HAND CORNER BETWEEN LOWER EQUIPMENT BAY  
AND LEFT HAND EQUIPMENT BAY

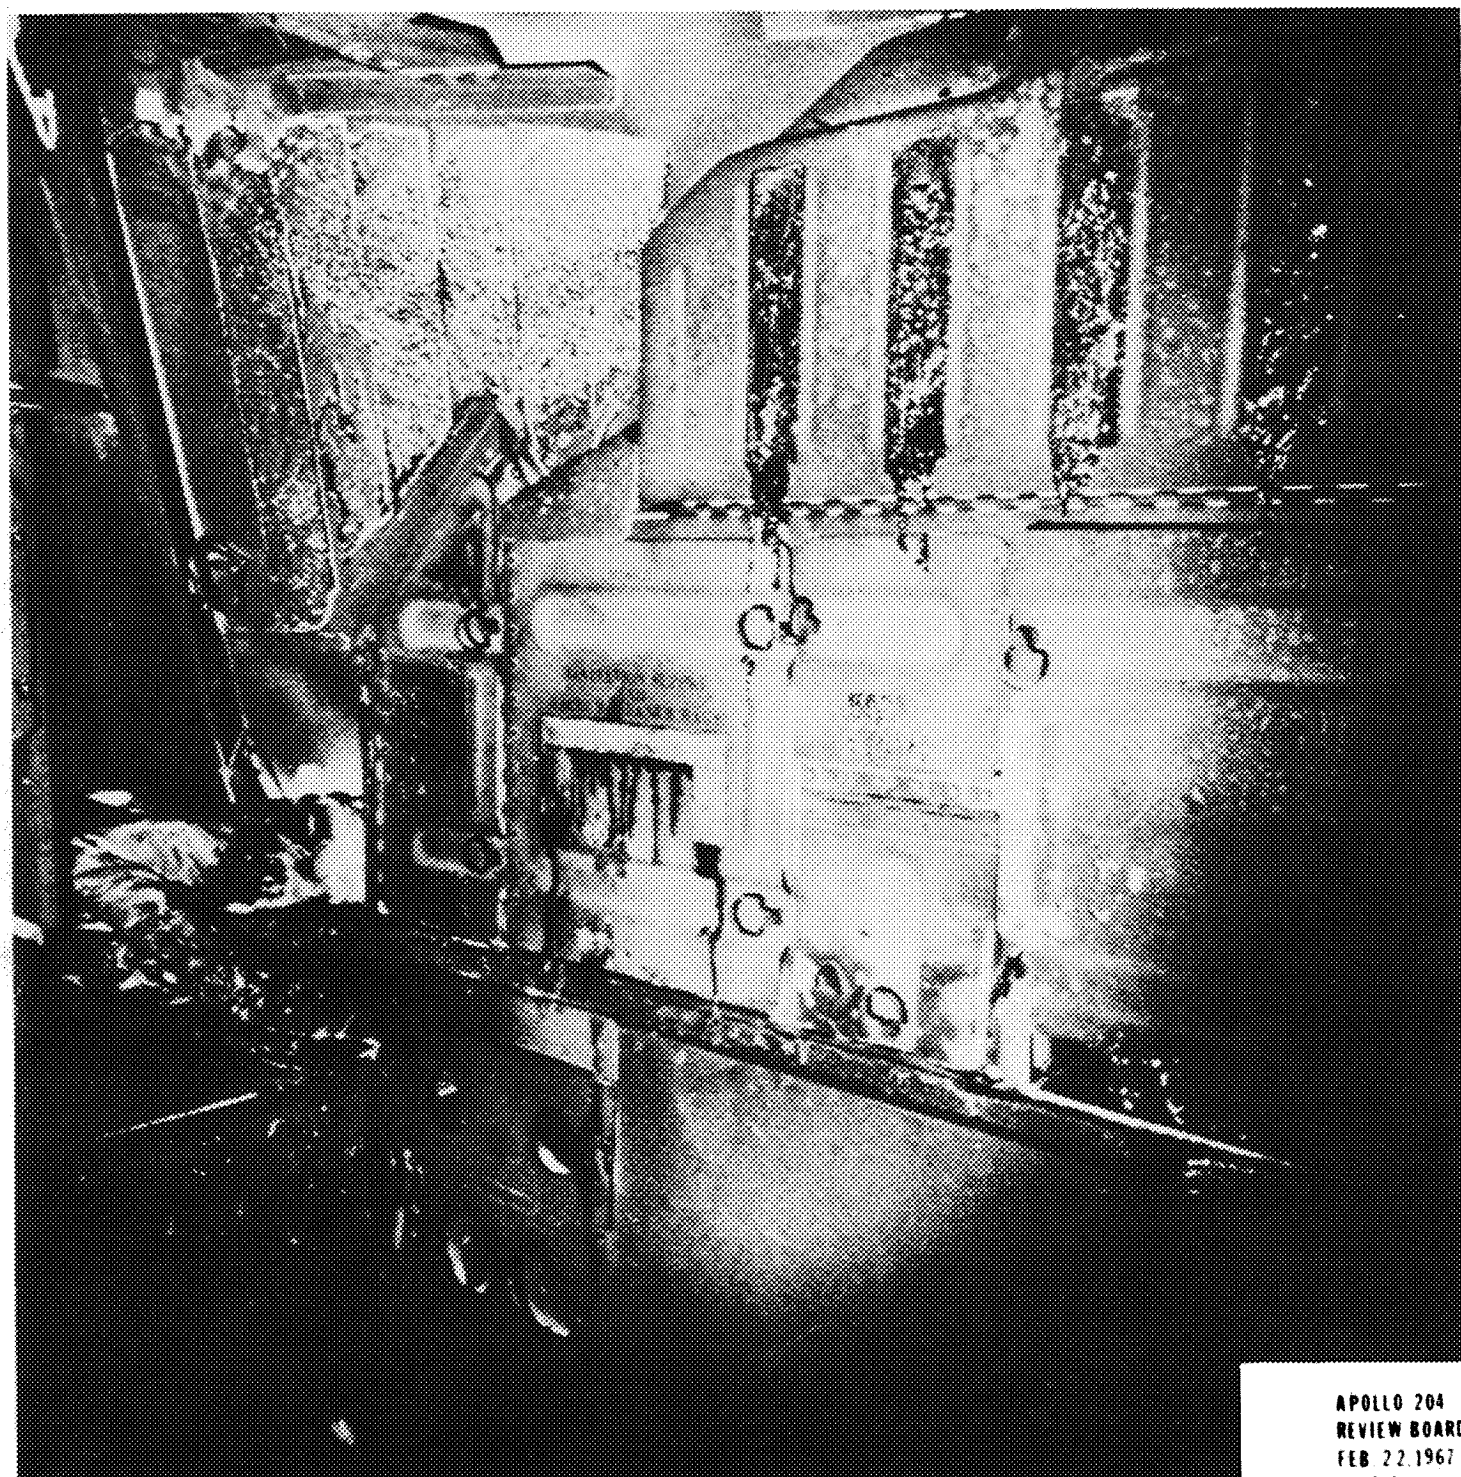
ENCLOSURE V-3

EXTREME RIGHT HAND CORNER ABOVE LOWER EQUIPMENT BAY AND RIGHT HAND EQUIPMENT BAY

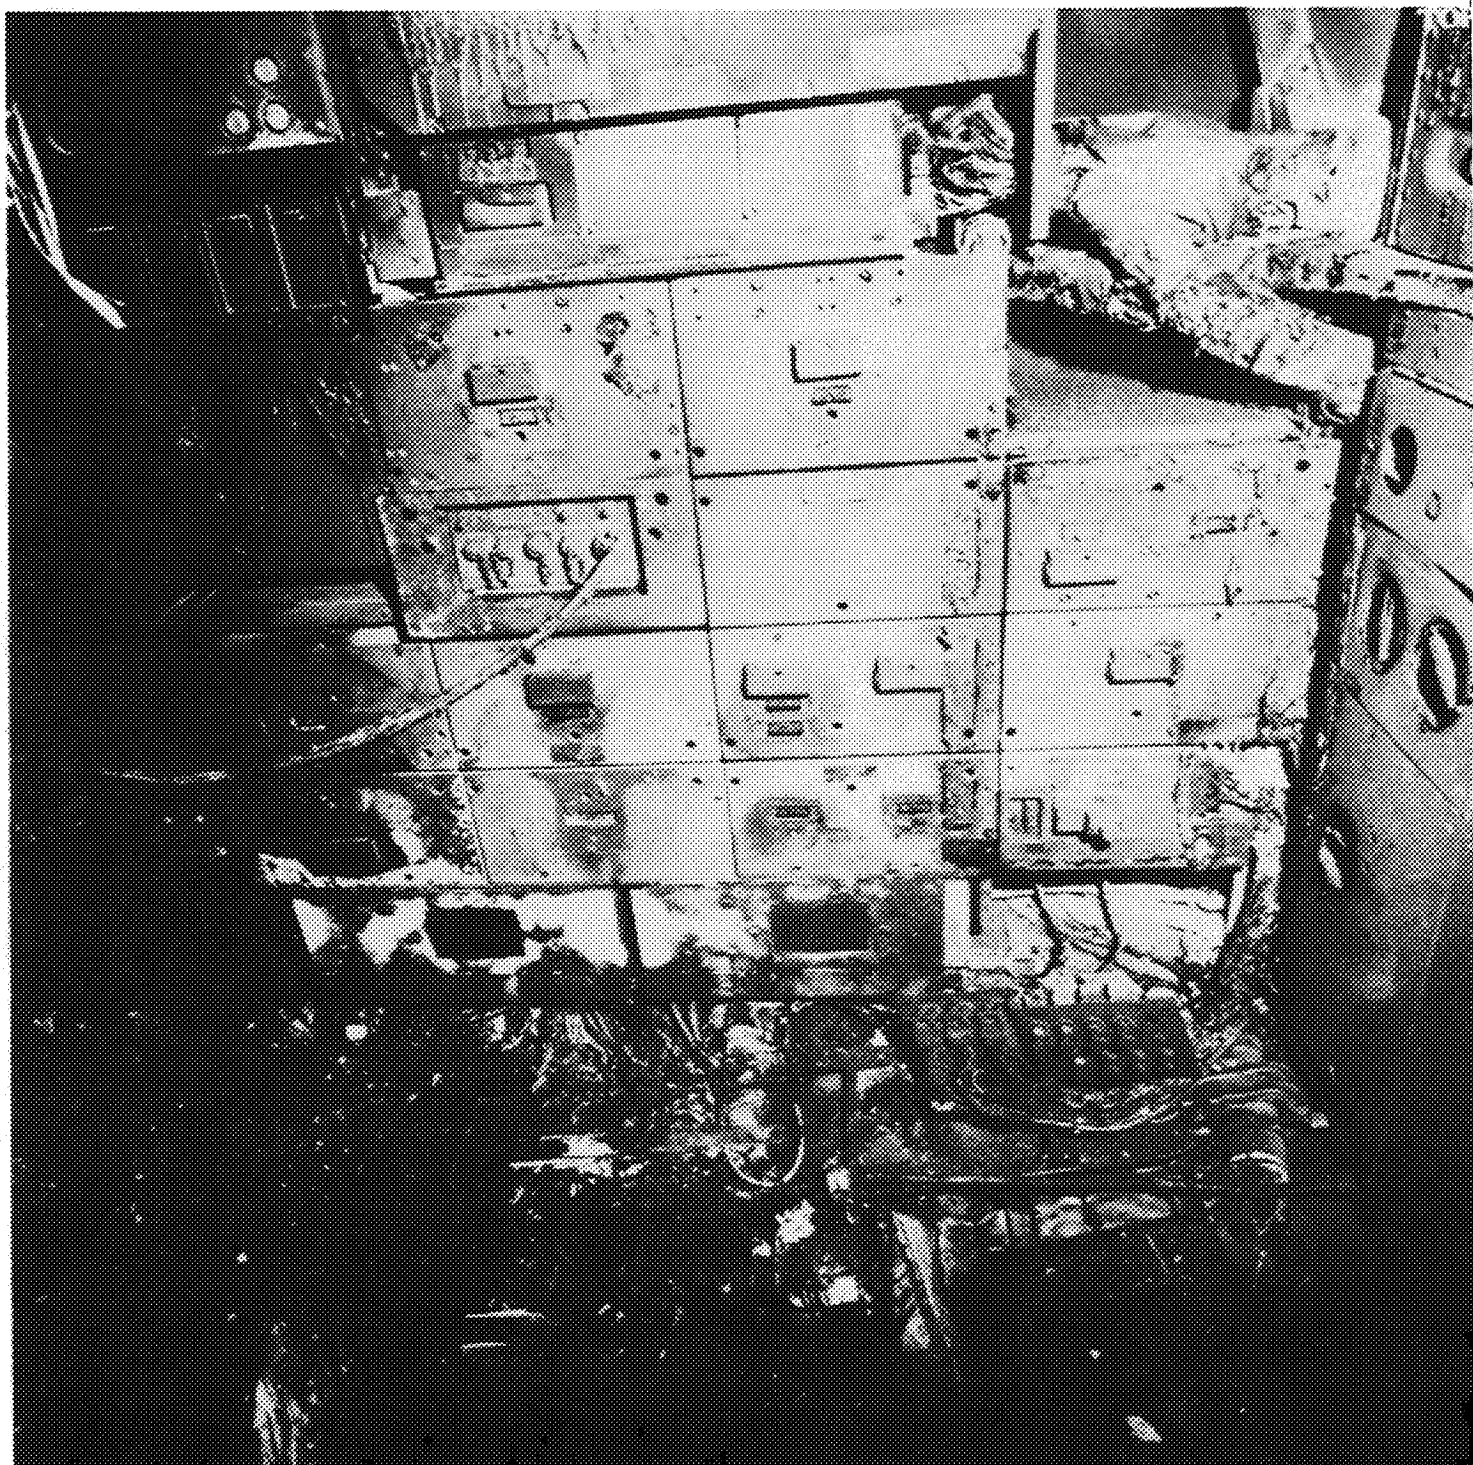
RIGHT HAND SECTION OF LOWER EQUIPMENT BAY

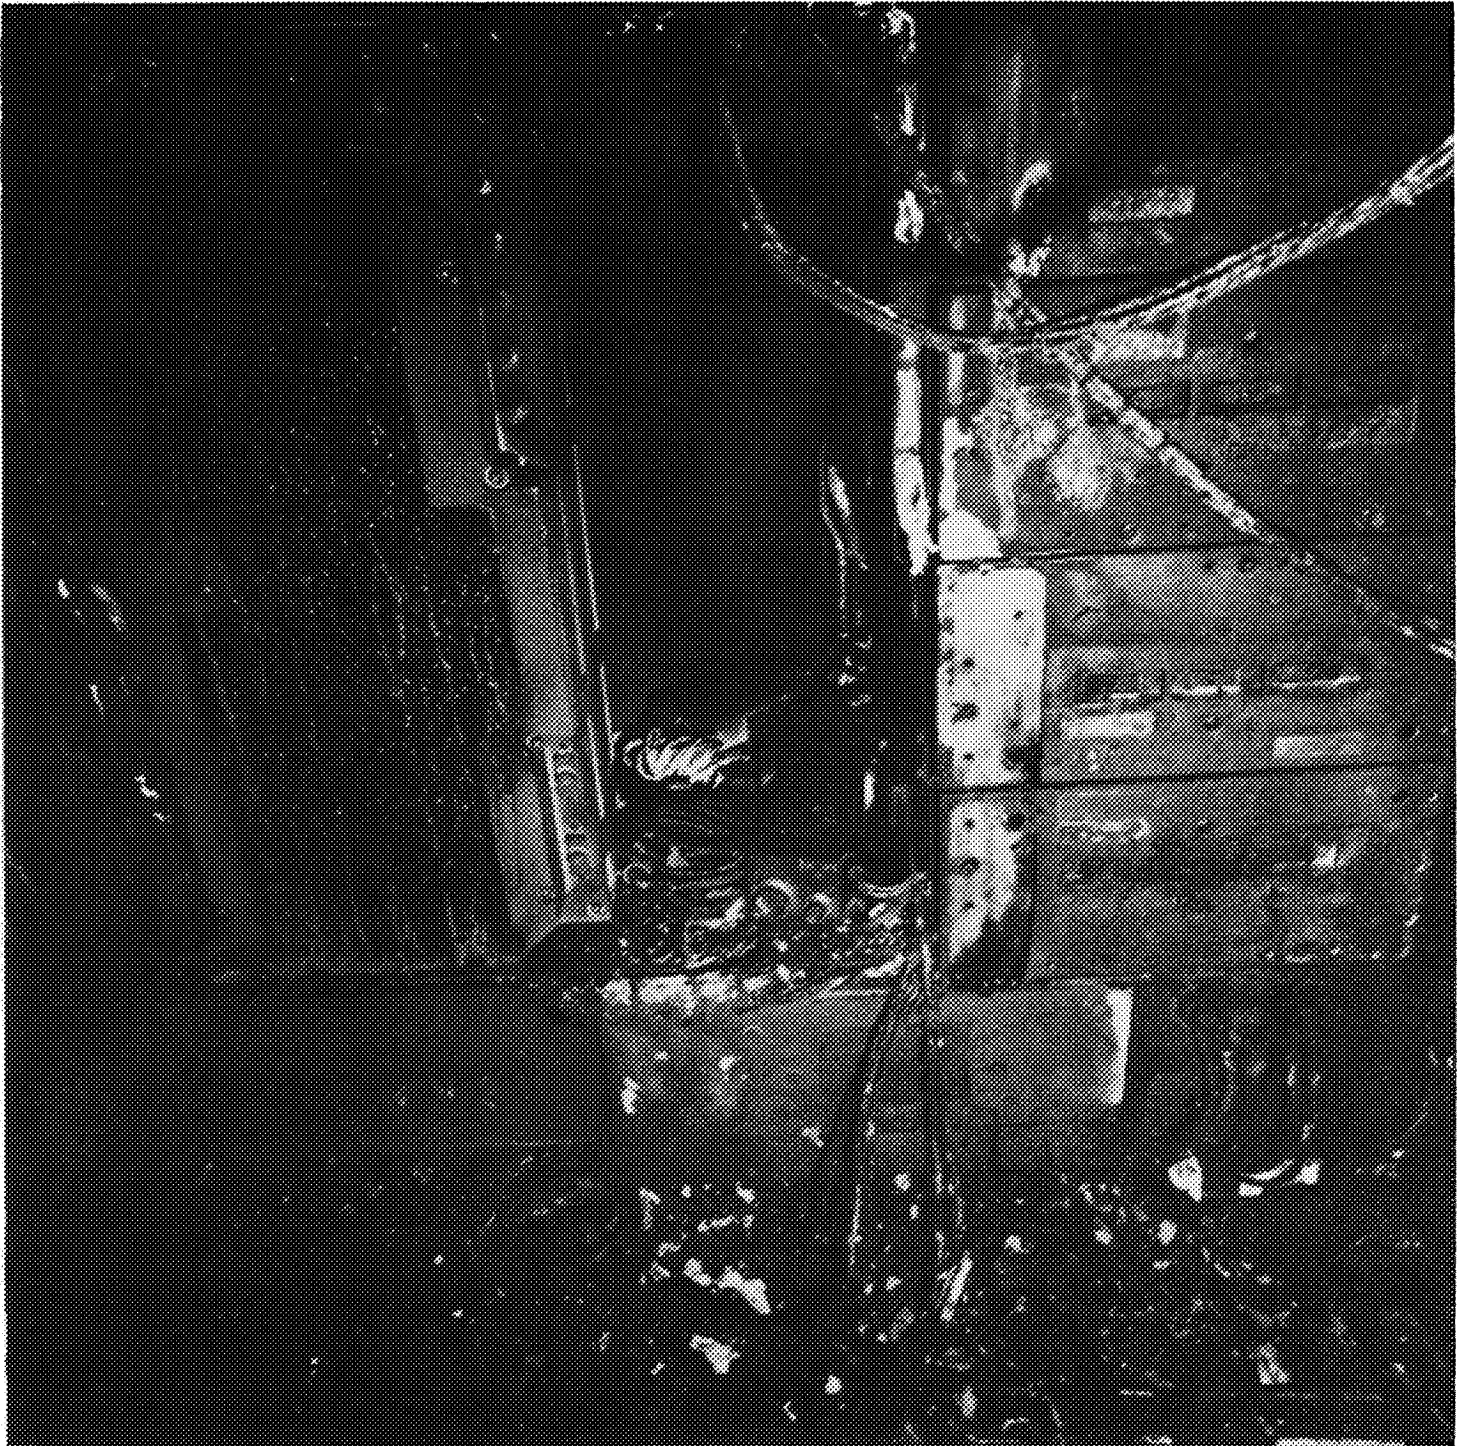
LOWER LEFT HAND SECTION OF LOWER EQUIPMENT BAY

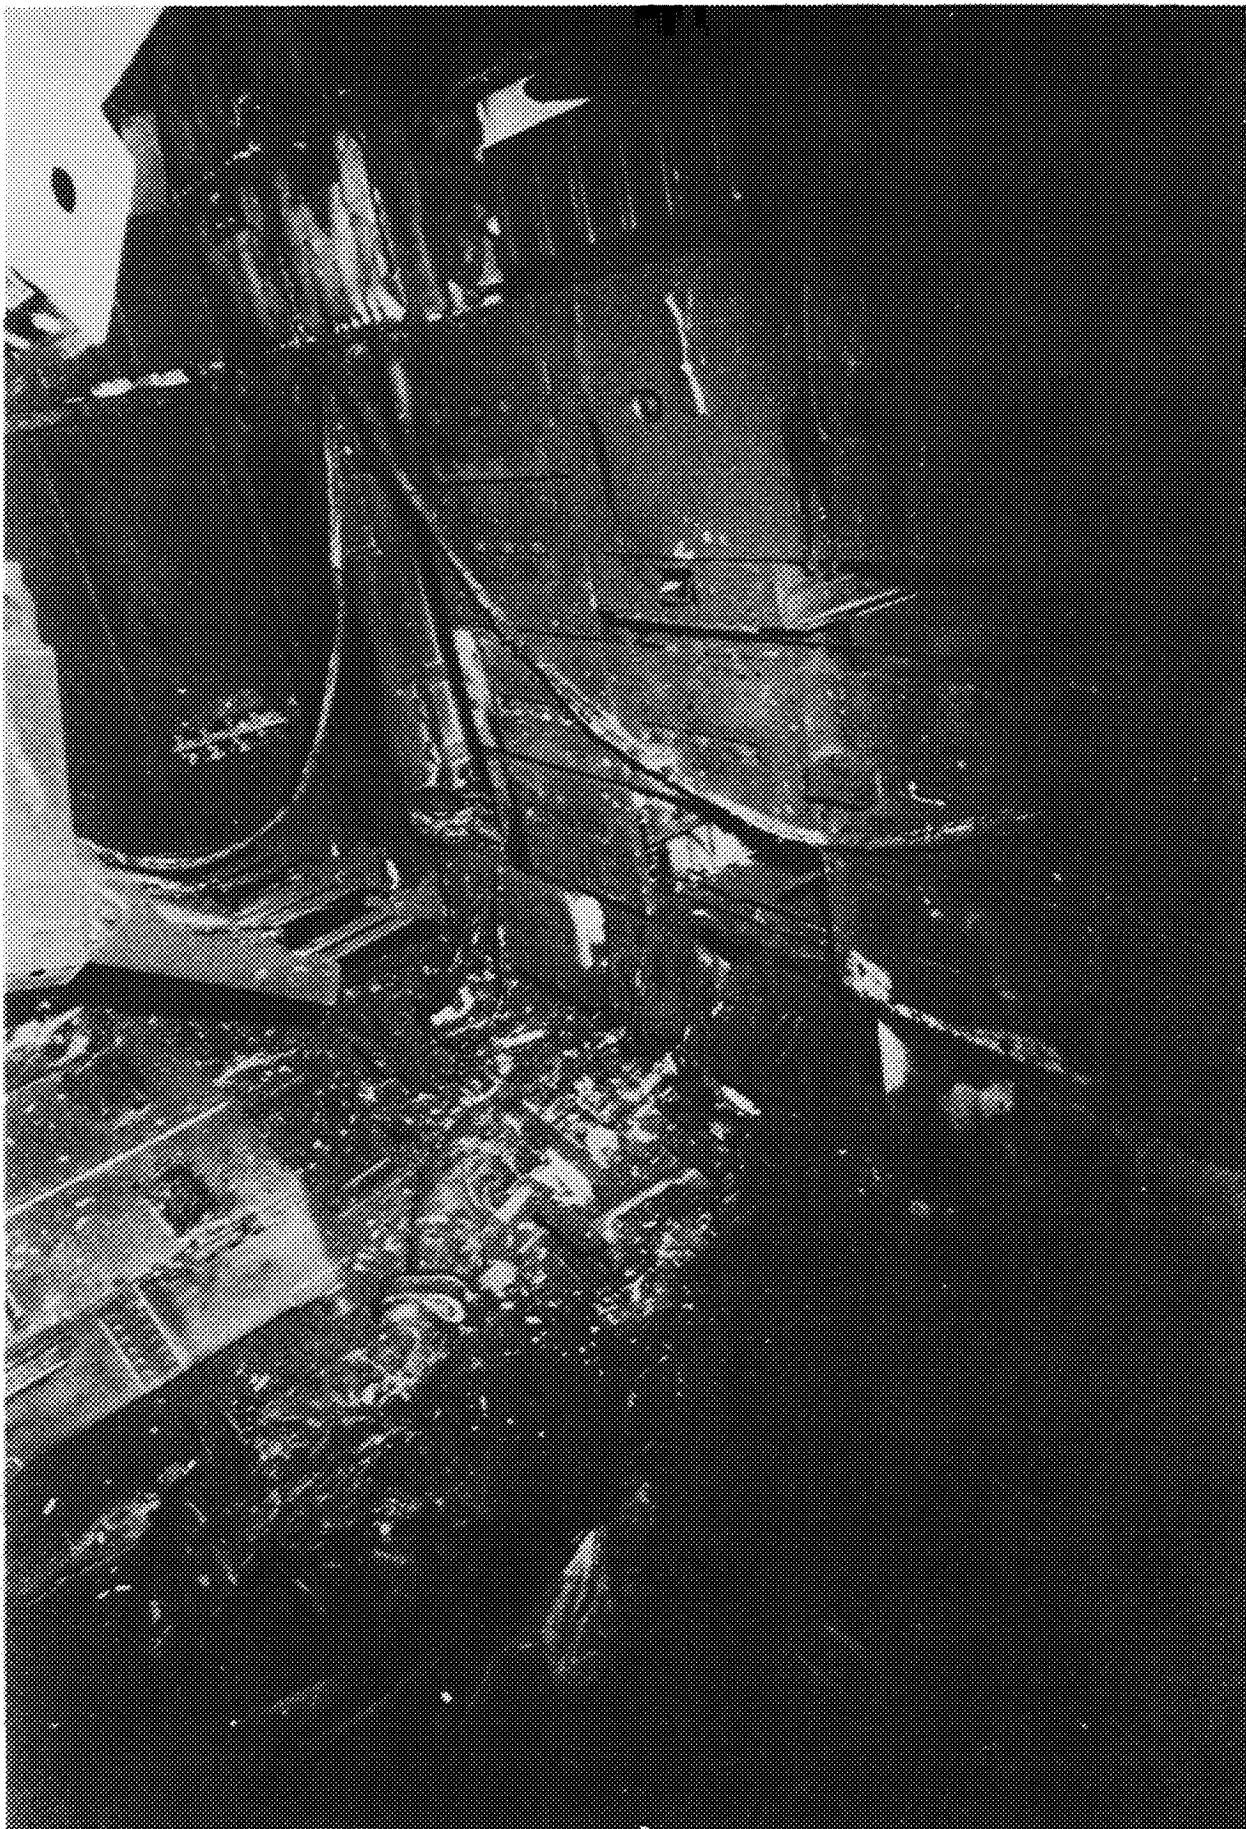
VIEW OF FLOOR BELOW LOWER EQUIPMENT BAY  
ENCLOSURE V - 6

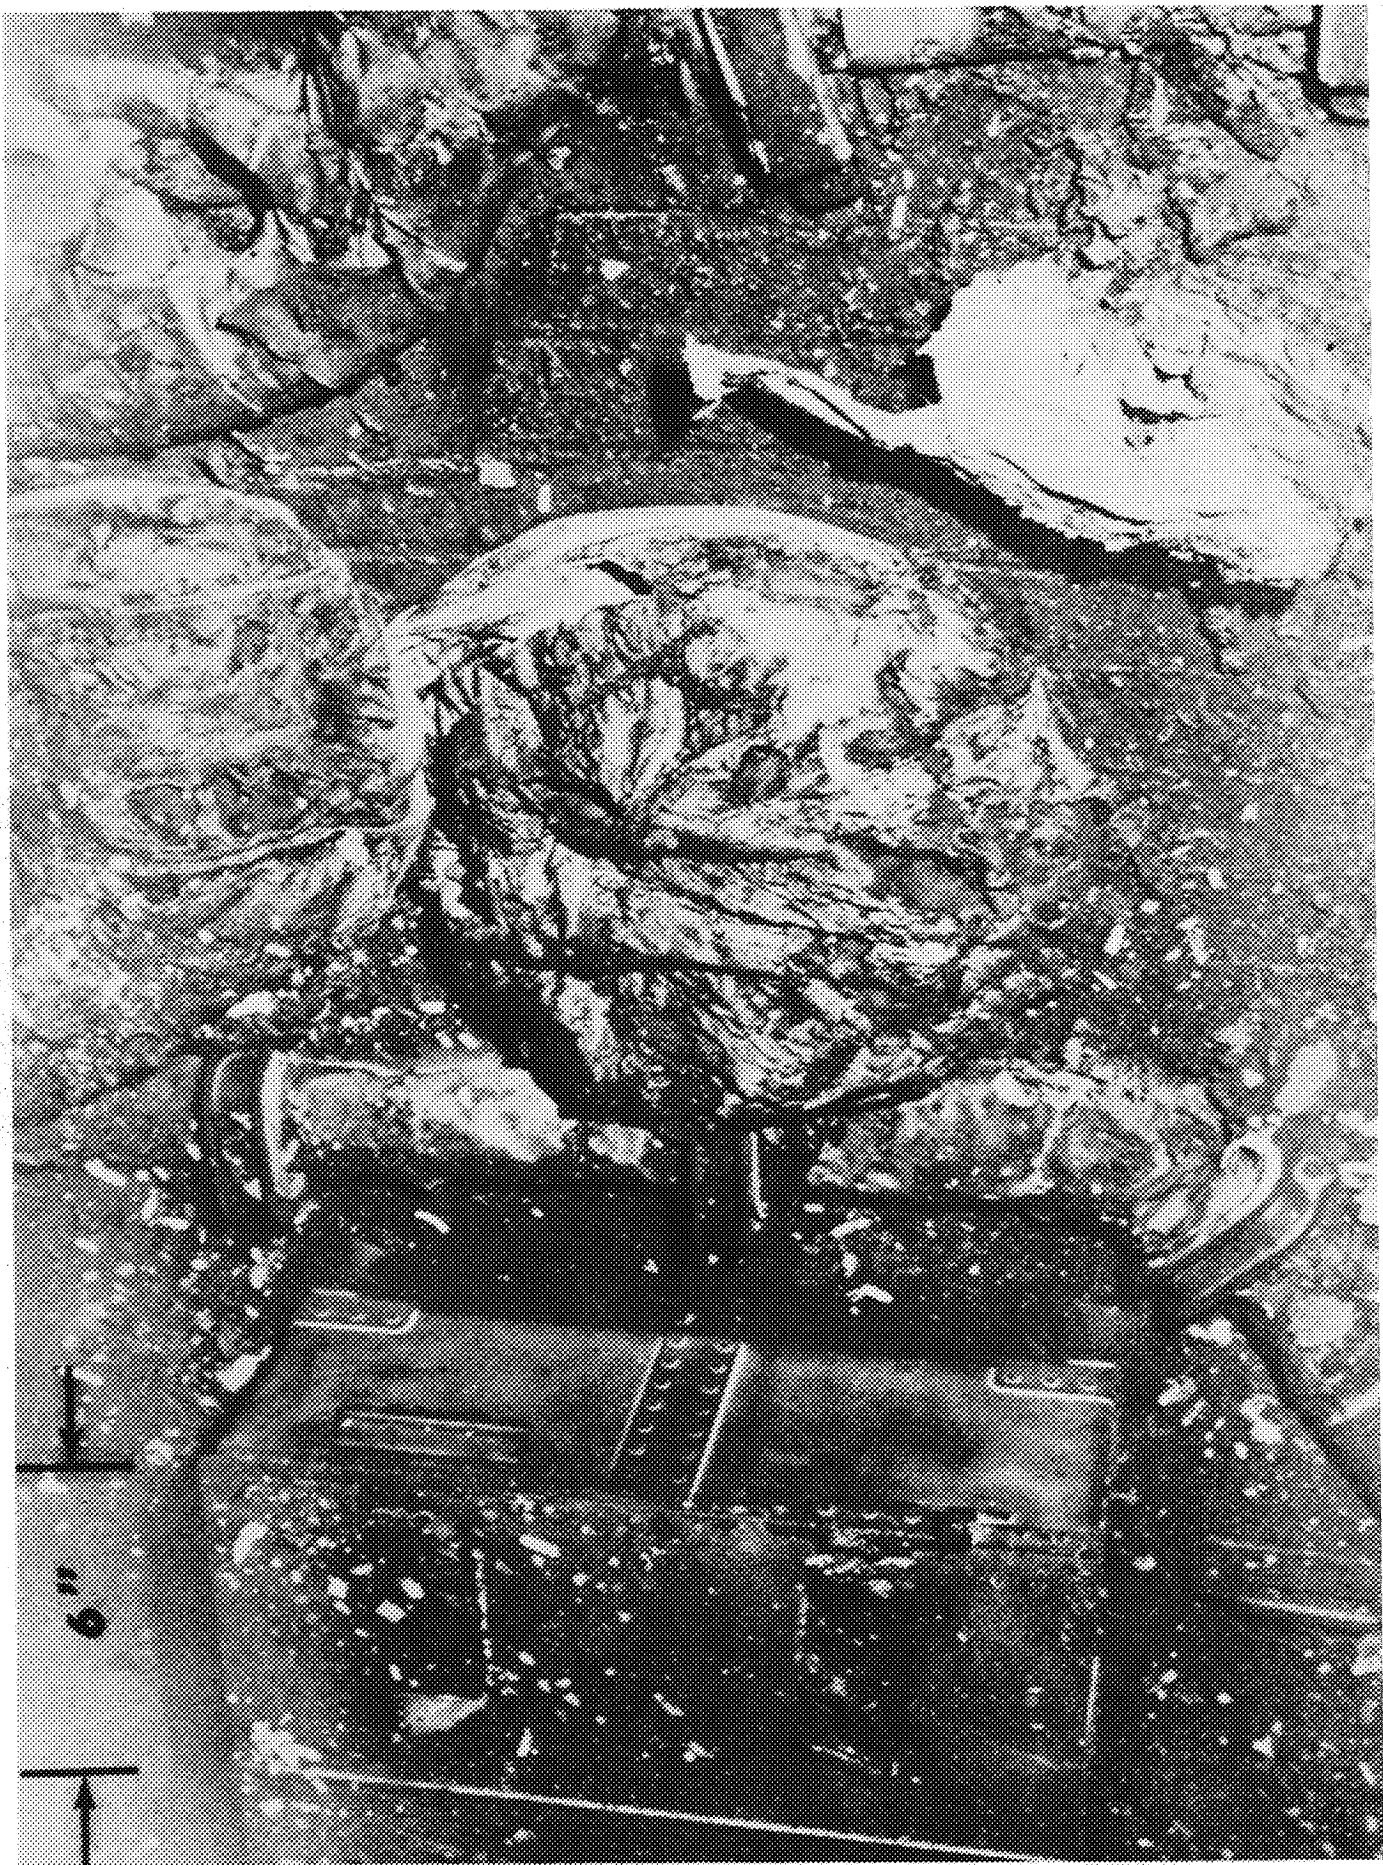
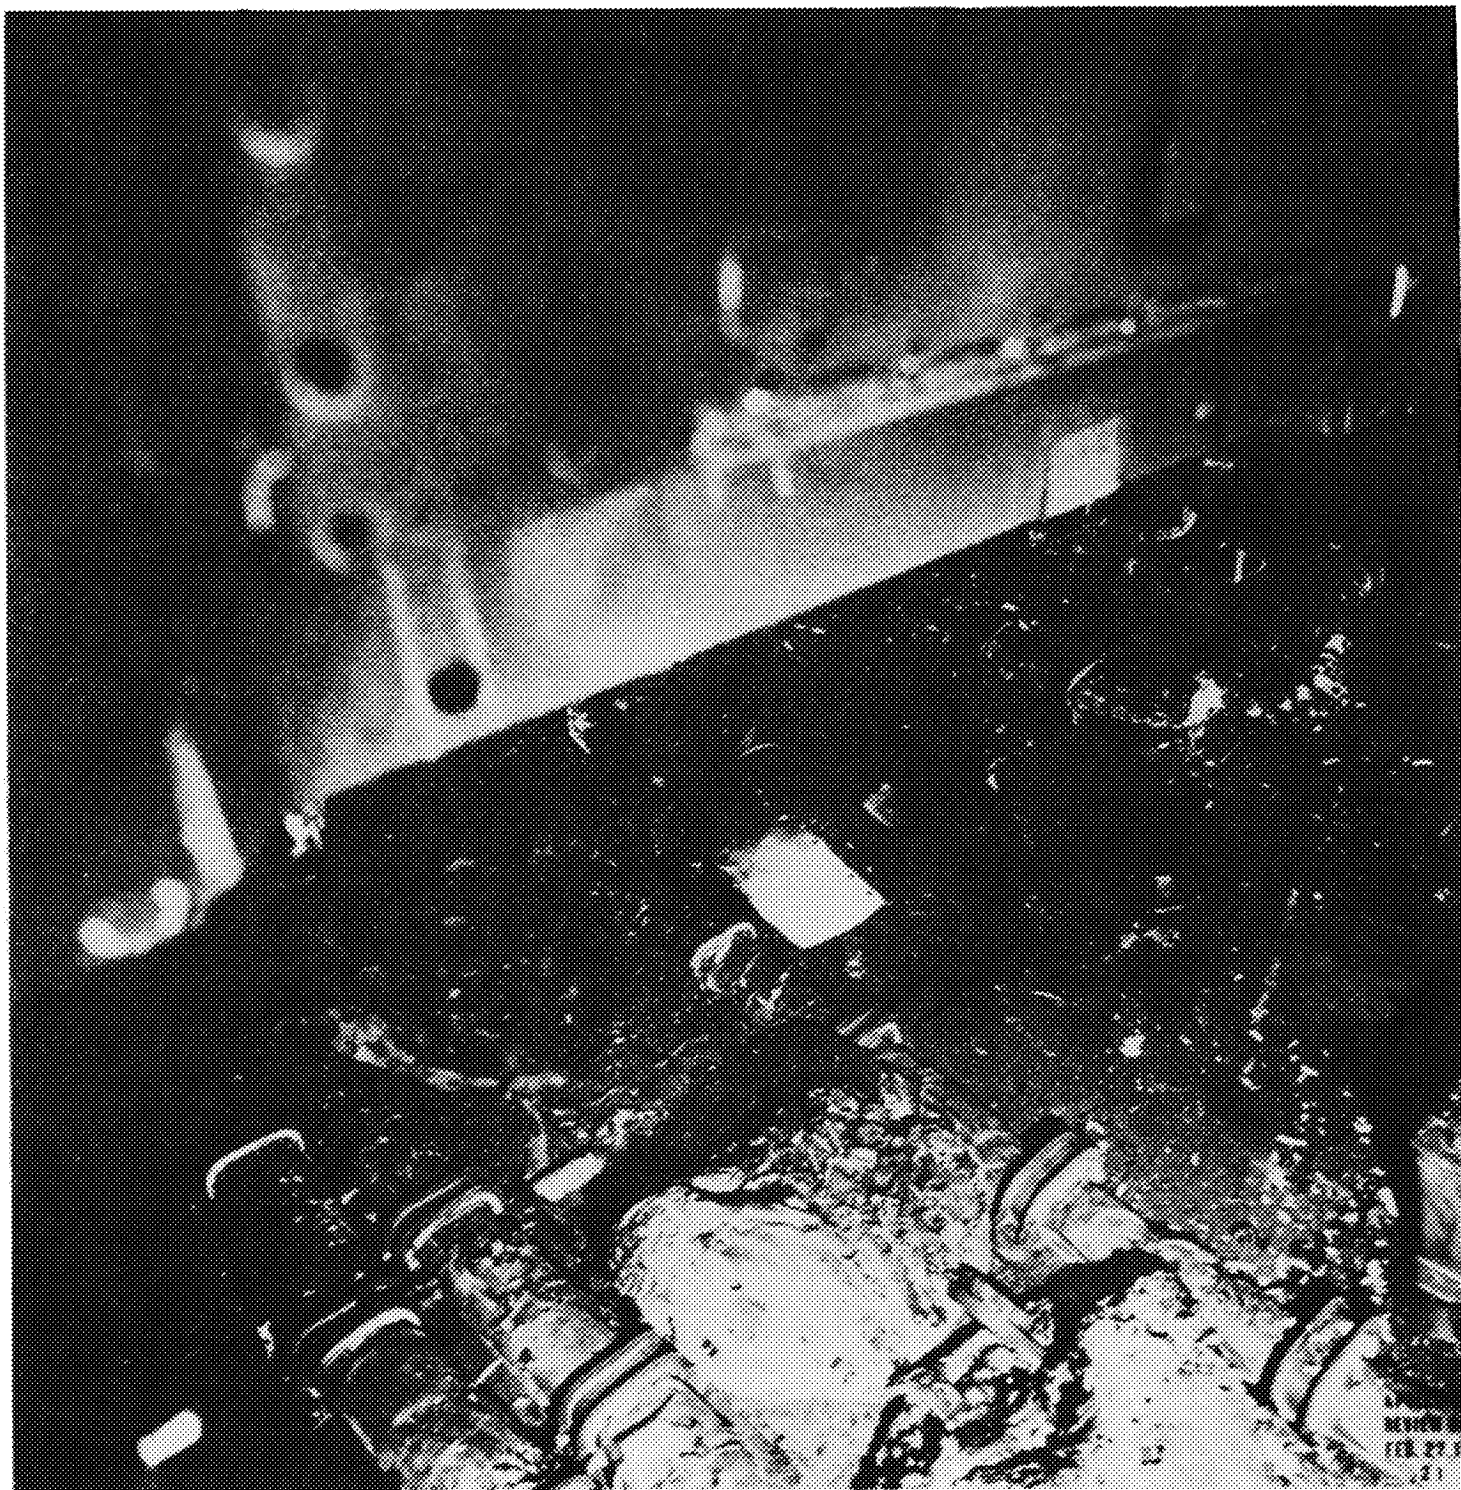
VIEW OF HELMET COVERS

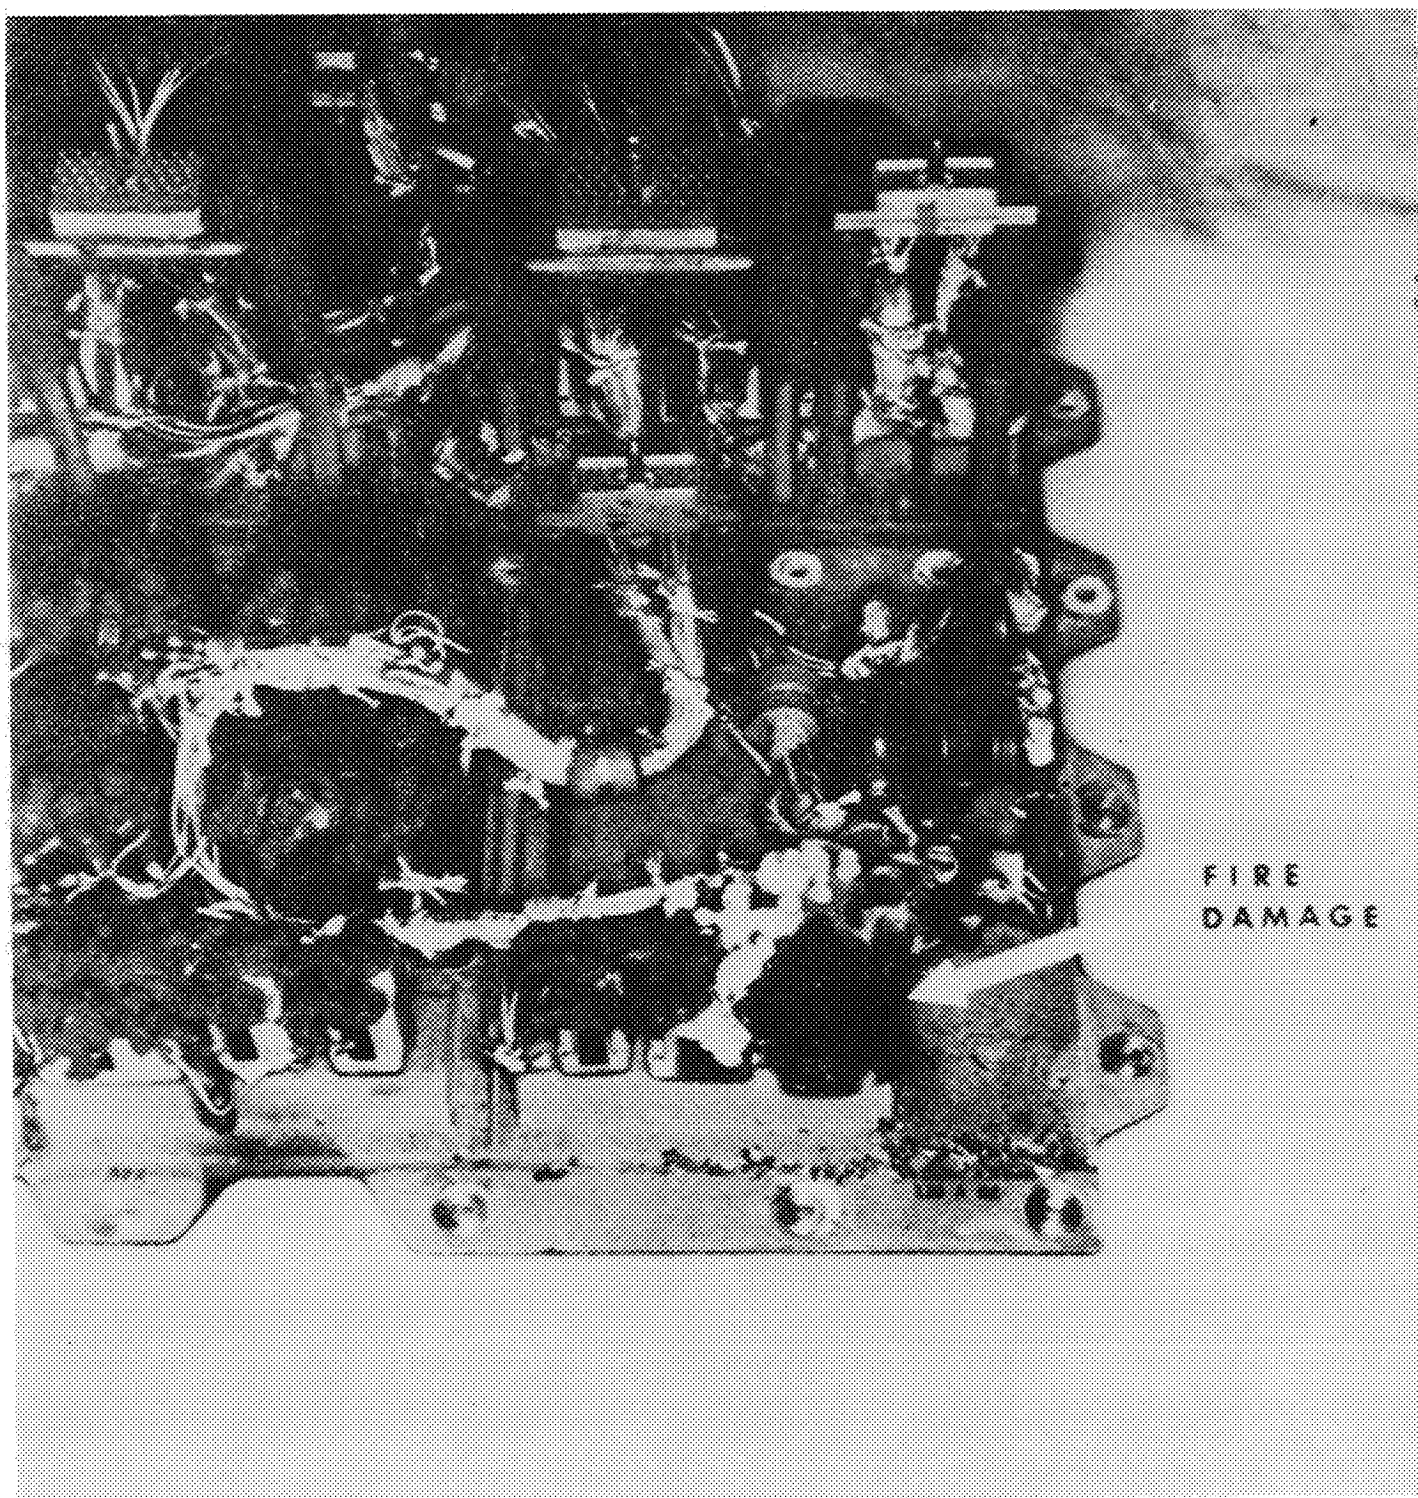
INTERIOR VIEW OF PANEL 13 SHOWING DAMAGE NEAR THUMB WHEELS

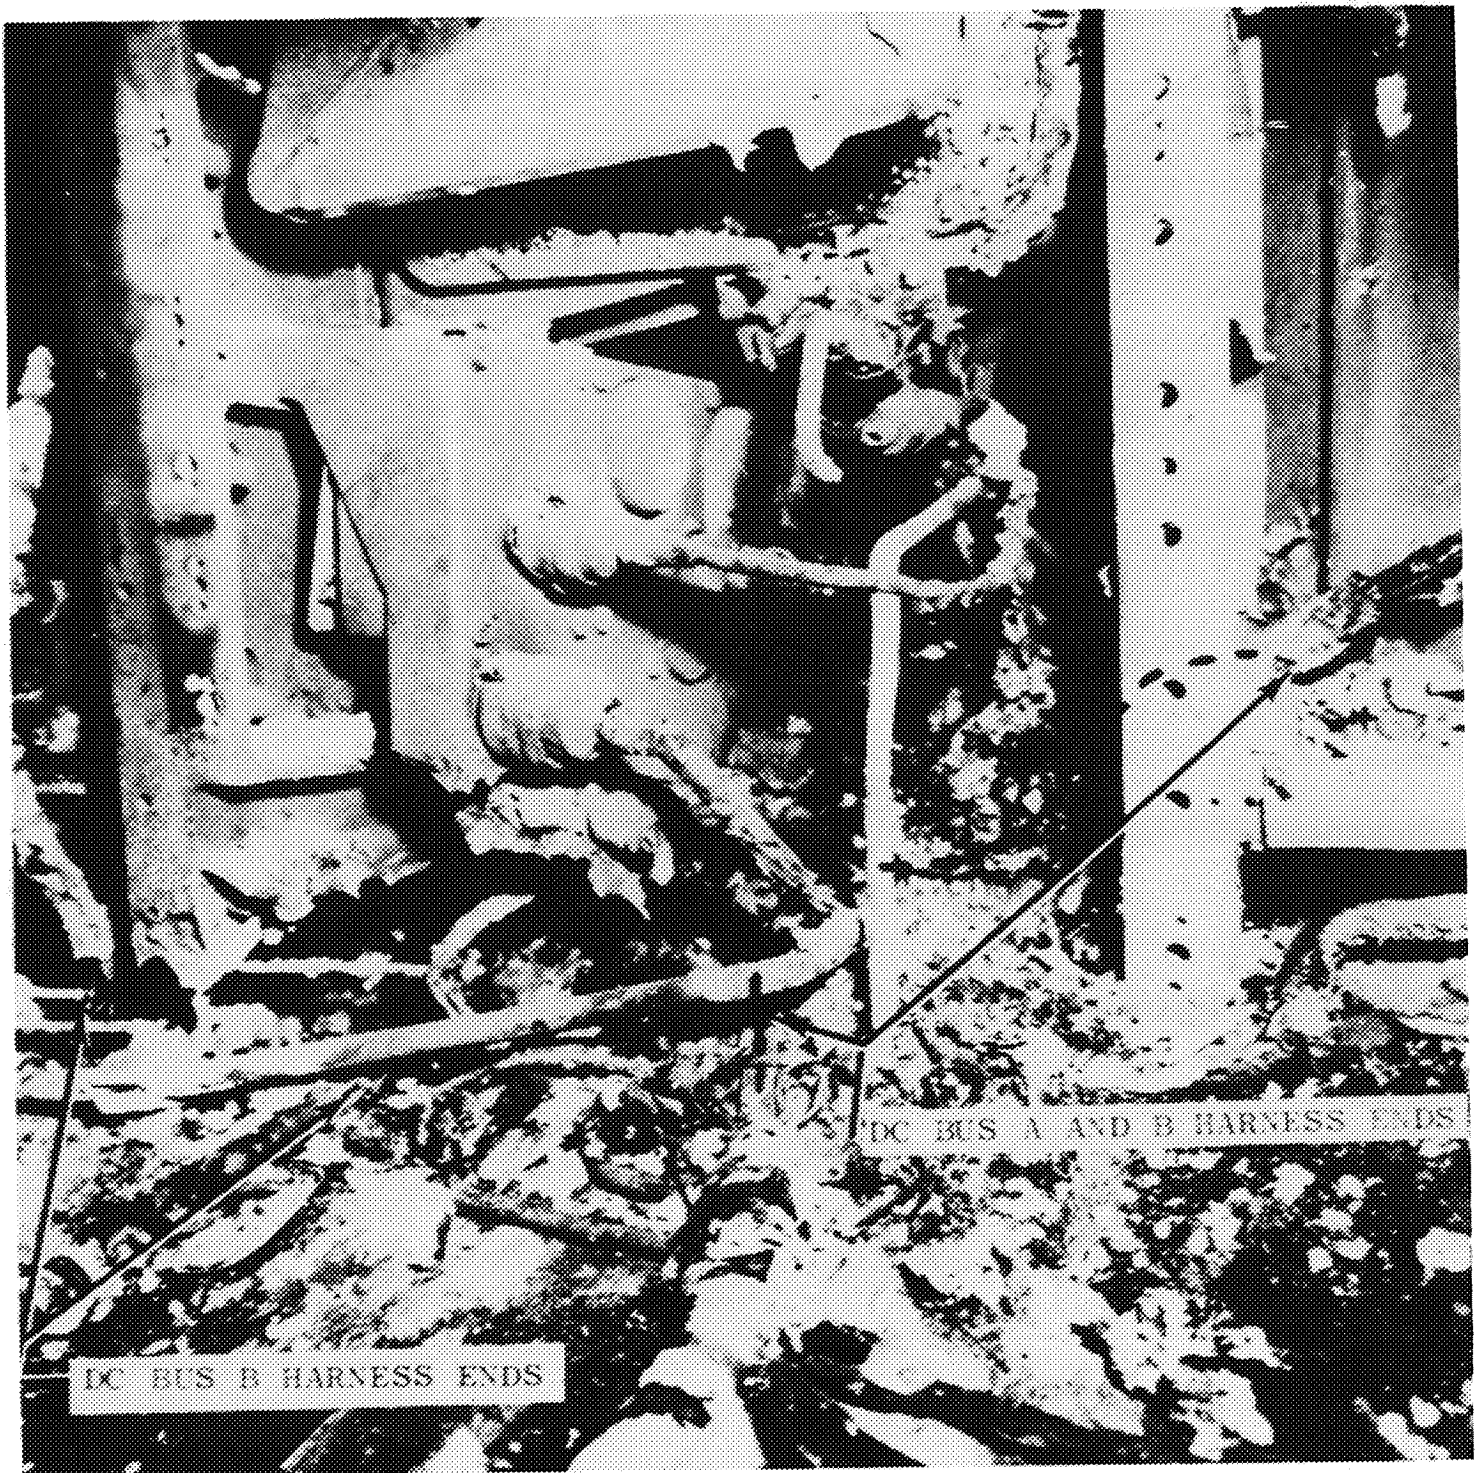
ENVIRONMENTAL CONTROL SYSTEM INSTRUMENTATION HARNESSES  
AFTER ACCIDENT

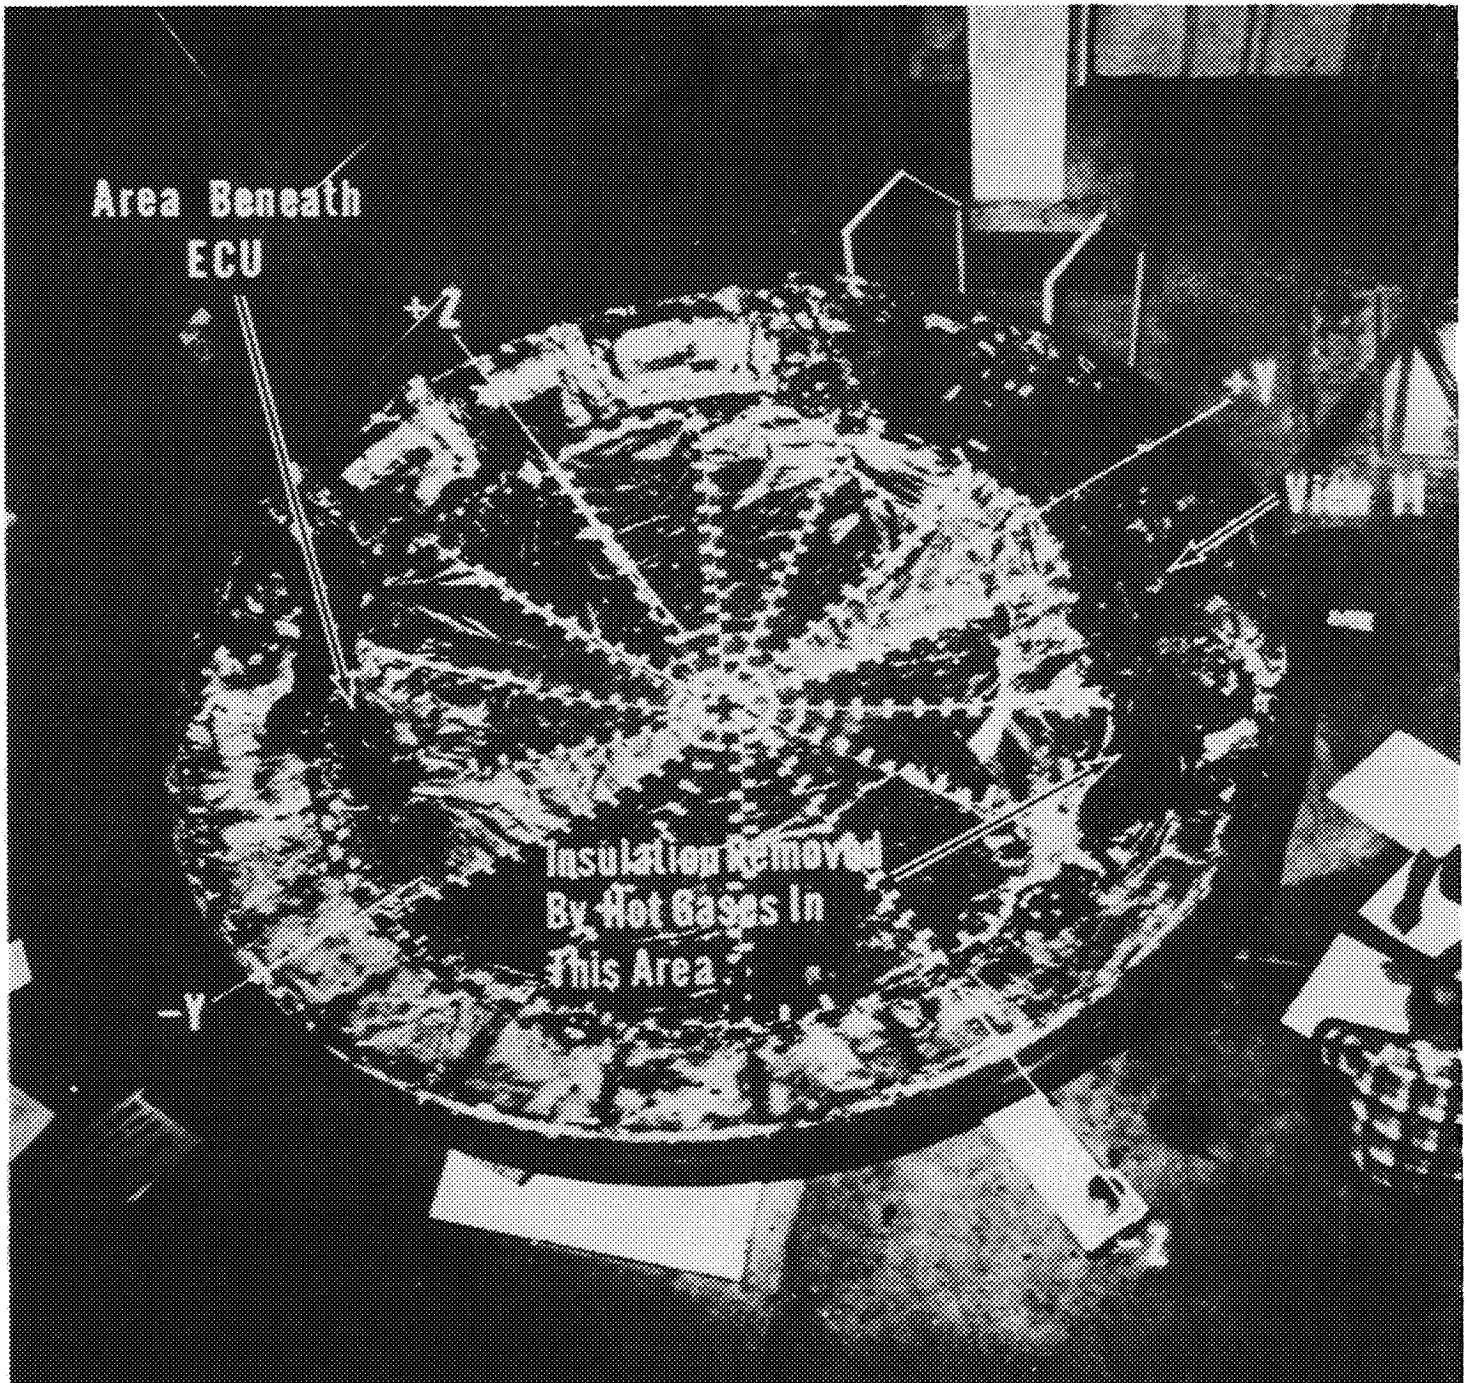
1. The aft heat shield was removed from C/M 012 in accordance with the master plan for disassembly. Close inspection of the C/M disclosed that the rupture in the floor extended approximately 2/3 around its circumference. This is much greater than originally estimated.

AFT HEATSHIELD DAMAGE
